CR NUMBER 20-13448	ACCIDENT DATE 08-23-20	ACCIDENT TIME 1641	DAY OF WEEK Sun	DAYLIGHT <input type="checkbox"/> DAWN OR DUSK <input type="checkbox"/> DARK
-----------------------	---------------------------	-----------------------	--------------------	--

LOCATION OF ACCIDENT (STREET NUMBER OR OTHER LOCATION DESCRIPTION) 810 Morris Rd Kent OH 44240	WEATHER Cloudy
---	-------------------

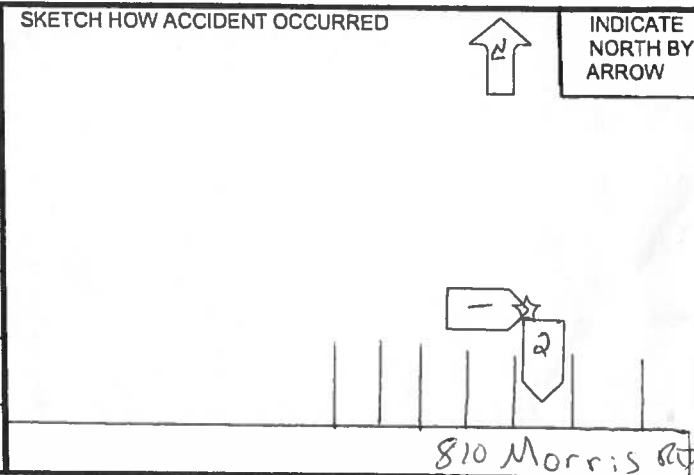
DESCRIBE HOW ACCIDENT OCCURRED  
Unit 1 was traveling east through the parking lot, Unit 2 was backing from south to north out of a parking lot. Unit 2 did not see Unit 1 and backed into the front passenger side of Unit 1.
